MERRIMACK RIVER BASIN
TILTON, NEW HAMPSHIRE

TILTON TOWN DAM
NH 00151

PHASE I INSPECTION REPORT
NATIONAL DAM INSPECTION PROGRAM

JULY 1979

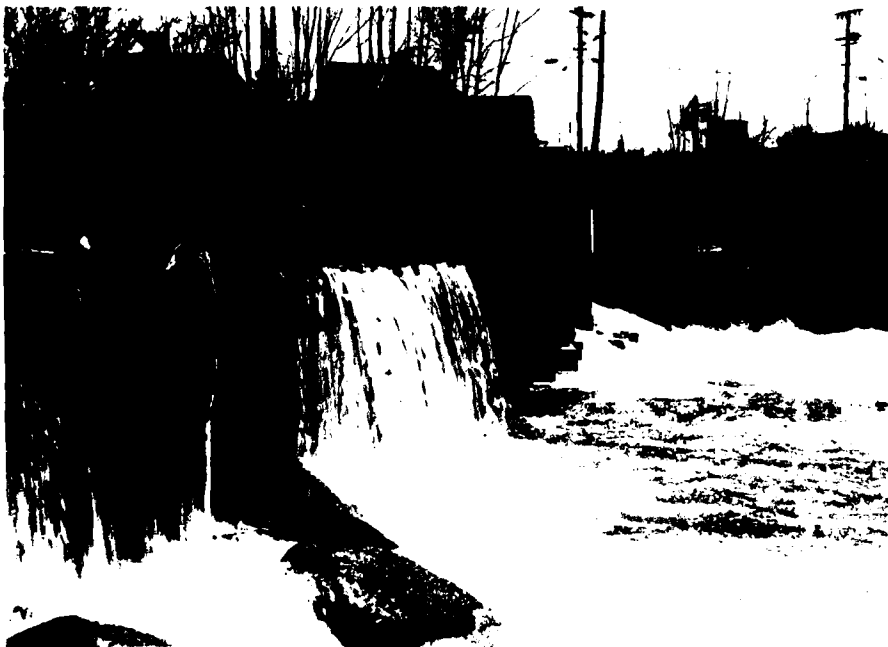
The timber frame of the dam is, in part, in poor condition and badly deteriorated. Confirmation of some local support failures was made. (See Appendix C - Figure 5.) The timber decking over the upstream face is in very poor condition. (See Appendix C - Figure 6.) Major quantities of water are pouring through large holes in the decking and lesser quantities through leaks along the entire length of the spillway. (See Appendix C - Figure 5.) Near the south abutment is a hole several feet in diameter in the decking and a whirlpool several feet in diameter was observed over this hole. (See Appendix C - Figure 7.)

Figure 5 - Looking at the spillway where local support failures have occurred. Note the water discharging through the spillway through holes in planking.

The owner should engage a registered professional engineer to design and supervise appropriate repairs to the sinkhole over the masonry pipe in south abutment and to the existing structure such as masonry frame, decks, gates, lift mechanisms, etc. Attention should also be paid to the possibility that the silt collected behind the dam may contain pollutants which could affect the downstream reaches of the river.

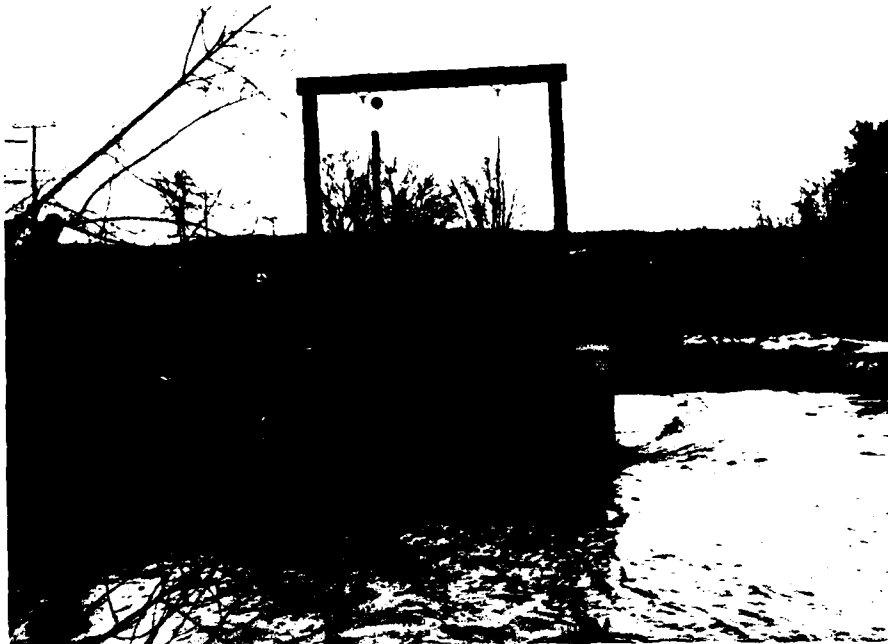
Figure 9 - View of the upstream face of the south abutment. Note the concrete box inlet structure.
